Manhole Inspection Summary

Manhole # S63K__010MH

Insp Date: **6/16/08 10:22 AM**

Location Address: **831 Umbra St.**

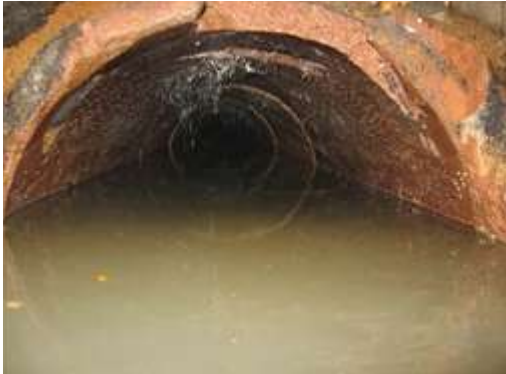
Defect 1

Pipe has crack multiple 11:00-2:00 which would affect the pipe seal.

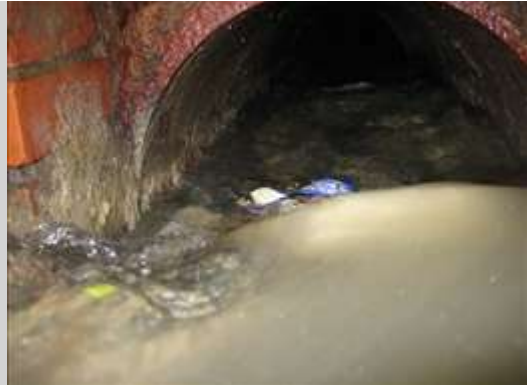
12 O'Clock Outflow

18 in. Circular Gravity Sewer
Pipe Out @ 12 O'Clock

Pipe Height: **18** (in.) Rod and Bar (Angled)
Pipe Material: **Clay** ☐ Pipe Lined
Invert Depth: **35.71** (ft.) Flow Characteristics: **Fast**
Deposits: ☐ None ☐ Mud ☐ Sludge ☒ **Debris** ☐ Grease
Silt Depth: **1** (in.) Deposits Extent: **Light**
Infiltration: **None** Pipe Seal Cond: **Sound**

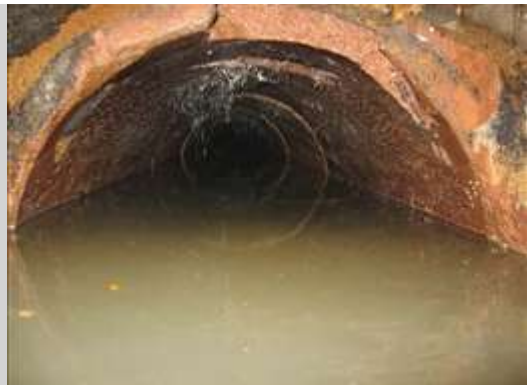
5 O'Clock Inflow

18 in. Circular Gravity Sewer
Pipe In @ 5 O'Clock

Pipe Height: **18** (in.) Rod and Bar (Angled)
Pipe Material: **Clay** ☐ Pipe Lined
Invert Depth: **35.25** (ft.) Flow Characteristics: **Slow**
Deposits: ☒ **None** ☐ Mud ☐ Sludge ☐ Debris ☐ Grease
Silt Depth: (in.) Deposits Extent:
Infiltration: **None** Pipe Seal Cond: **Cracked**
